## TREE PRESERVATION PLAN AND ARBORIST REPORT

Prepared for North Design Office Inc.  
9 Madison Avenue Toronto

FEBRUARY 6, 2018

ADDRESS: 9 MADISON AVENUE. TORONTO. M5R 2S2

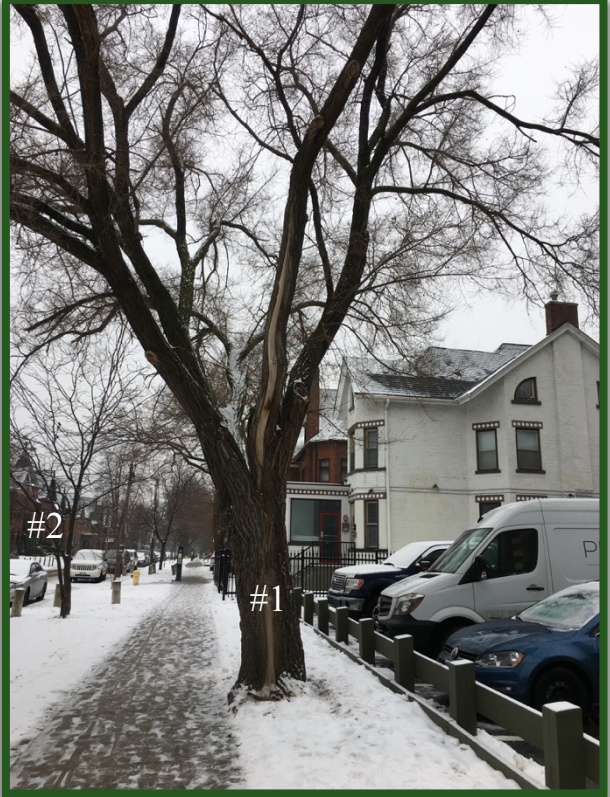
FIGURE 2: TREE #1

Tree #1 (city owned) is being recommended for removal because it is in the footprint of proposed development and would not likely survive additional injury due to current lack of vigor. The 70cm (DBH) Siberian Elm has several defects and its overall condition is “Poor”.

- Large failures
  - 6-9 limbs, 3-8cm in diameter
- Included bark from main union to grade
- Large wound with decay at base, from grade to 1.2m up the main stem
- Large wound with decay on significant limb (approx. 20cm in diameter)
  - Limb overhanging sidewalk and road
  - Wound is 1m long, 20% of the diameter of the limb, and on the tension side
- Large wound with decay on significant limb (approx. 25cm in diameter)
  - Wound is 3.5m long from the main union, 10% of the diameter of the limb, with borer holes and signs of insect activity present
- Cavities and decay on large limbs (25cm)
- hanging deadwood
  - 2 limbs, 1-3cm in diameter
- Large deadwood
  - 8-10 limb, 3-5cm in diameter
- 20% of the total canopy is deadwood
- 15% of natural canopy previously failed

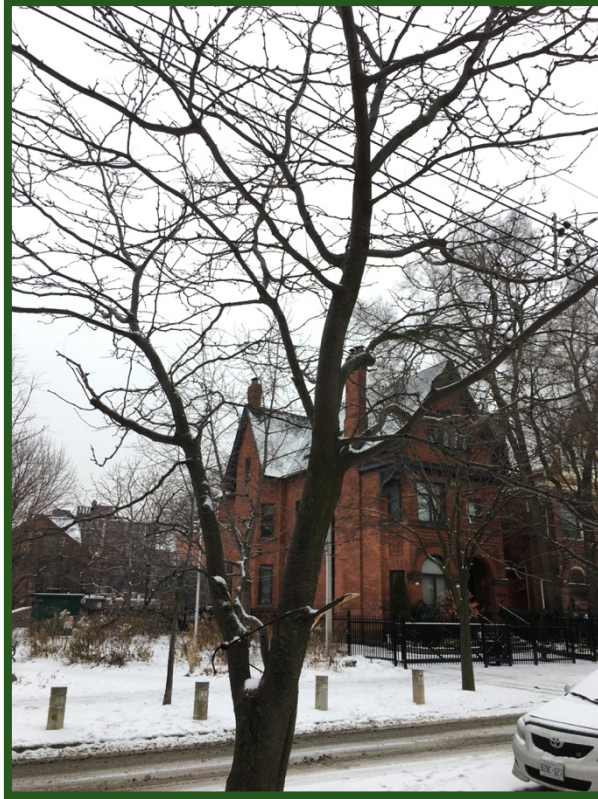
FIGURE 5: TREE #2 CANOPY

| Tree # | Species | Common Name | DBH (cm) | Category | Condition | Comments on Condition | TPZ (m) | Recommendation | Rationale | Injury Mitigation |
|---|---|---|---|---|---|---|---|---|---|---|
| 2 | <i>Gleditsia triacanthos 'Skyline'</i> | Honey Locust | 16 | 5 | Fair | co-dominant stems with included bark, lean to west, irregular root flare, mechanical damage on the lower limbs, imbalanced canopy from utility wire clearance | 1.8 | Protect | Maintain full TPZ protection | N/A |

Tree #2 (city owned) will maintain a 1.8m tree protection barrier with no infringement on the north-west side of the property.

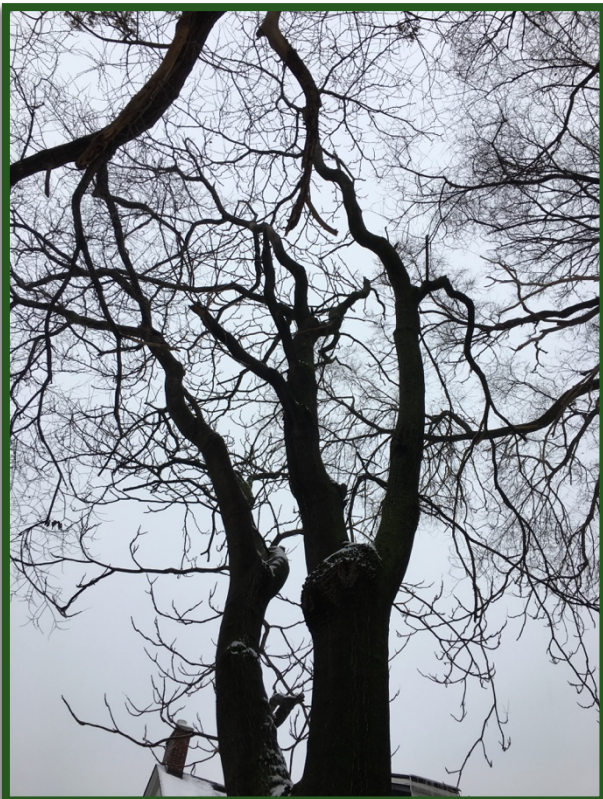
FIGURE 8: TREE #3 CANOPY

Tree #3 is being recommended for removal because it is in the footprint of the proposed building and would not likely survive additional injury due to current lack of vigor. The 44cm (DBH) Tree of Heaven has several defects and its overall condition is “Poor”.

- Large failures
  - 7 limbs, 3-10cm in diameter
- Failed co-dominant stem (approx. 20cm in diameter)
- Cavity formation throughout the canopy
- Damage at the base
- Small root zone from lack of available soft scape
- 20% of the total canopy is deadwood
- 10% of natural canopy previously failed

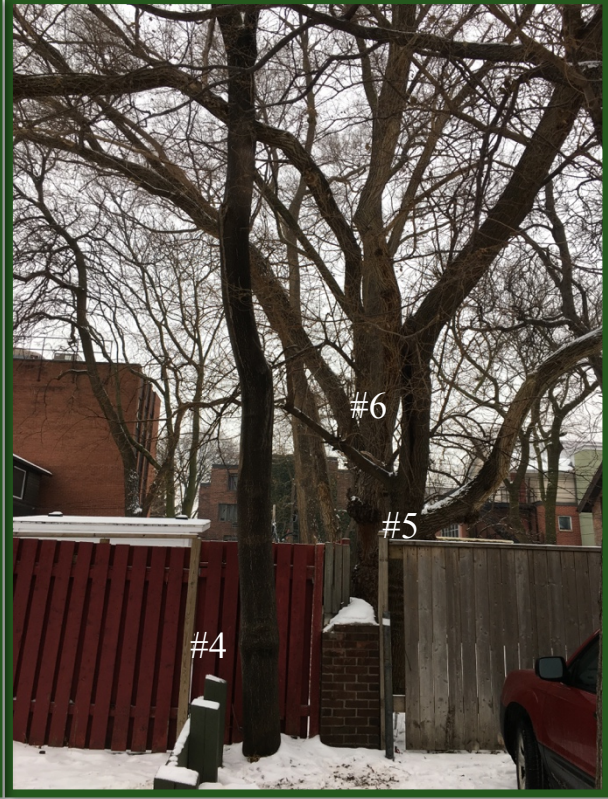
FIGURE 10: TREE #4 MAIN STEM

Tree #4 is being recommended for removal because it is in the footprint of the proposed building and would not likely survive additional injury due to current lack of vigor. The 32cm (DBH) Tree of Heaven has several defects and its overall condition is “Poor”.

- Large failures
  - 10 limbs, 3-5cm in diameter
- Vertical crack on the main stem
  - 2m in length
- Cavity formation throughout the canopy
- Damage at the base
- Small root zone from lack of available soft scape
- 15% of the total canopy is deadwood
- 30% of natural canopy previously failed

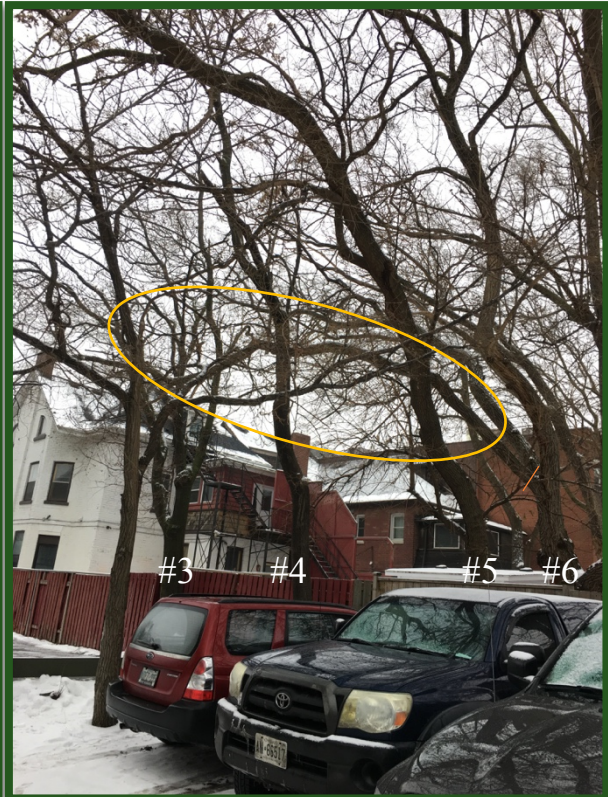
FIGURE 12: TREE #6 LIMB TO REMOVE

There is 1 neighbour owned tree (Tree #6) at 478 Huron St. on north-east of the proposed development that will be designated as “Preserved with Injury”. While the base of the main stem is >6m from the development, the 63cm Siberian Elm will require injury because 1 limb (approximately 20cm in diameter) will interfere with the proposed development area. The existing fence will act as a tree protection barrier and remain intact throughout the duration of construction. If at any time the fence is removed, a tree protection barrier must be installed at the same distance from the tree and in accordance with the City of Toronto document “Tree Protection Policy and Specifications for Construction Near Trees”.

Tree #6 (neighbour owned) is being preserved with injury based on the proximity on the canopy to proposed construction. The 63cm (DBH) Siberian Elm has several defects and its overall condition is “Fair”.

- Large failures
  - 6-9 limbs, 3-10cm in diameter
- Large deadwood
  - 8-10 limb, 5-15cm in diameter
- 20% of the total canopy is deadwood
- 15% of natural canopy previously failed

- ensure the existing fence remains intact and acts as a tree protection barrier or, if this is not possible, install a tree protection barrier to protect the full TPZ (4.8m) in accordance with the City of Toronto document “Tree Protection Policy and Specifications for Construction Near Trees”; and
- pruning 1 limb, approximately 20cm in diameter, on the south-west side of the tree will be required to provide at least 2m of clearance from the proposed structure and prevent damage to the remaining canopy.

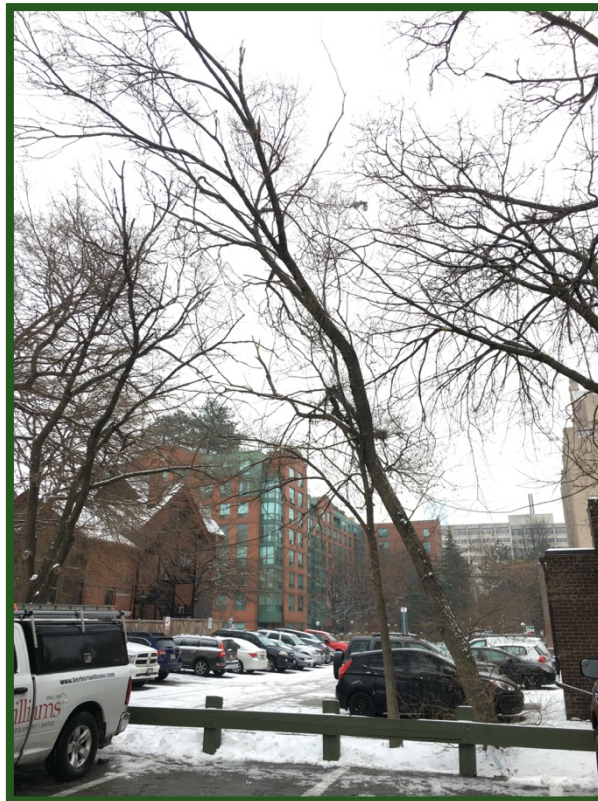
FIGURE 15: TREE #7

Tree #7 is being recommended for removal because it is in the footprint of the proposed building and would not likely survive additional injury due to current lack of vigor. The 37cm (DBH) Siberian Elm has several defects and its overall condition is “Poor”.

- Large failures
  - 3-6 limbs, 5-8cm in diameter
- Severe lean to the south west
- Irregular root flare
- Water-sprouting at the base
- Hanging deadwood
- 2 limbs, 1-3cm in diameter
- Large deadwood
  - 8-10 limbs, (3-8cm)
- 30% of the total canopy is deadwood
- 15% of natural canopy previously failed

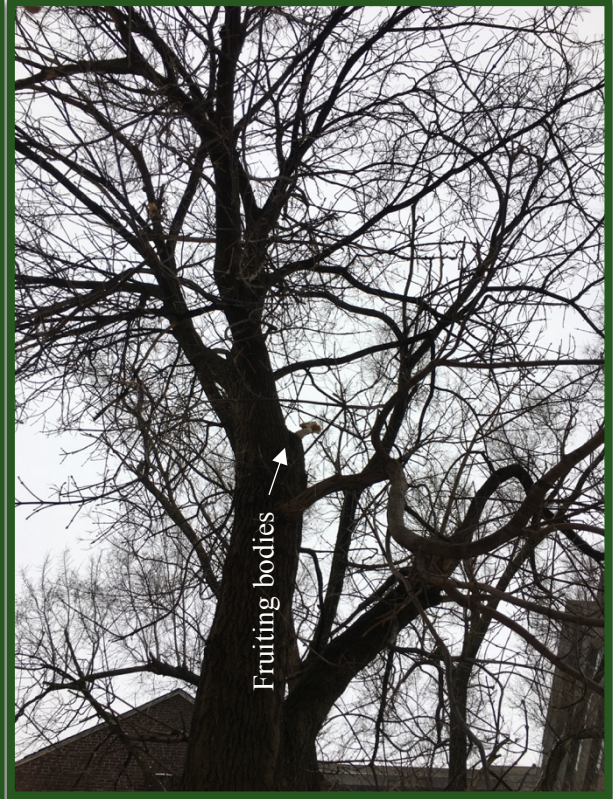
FIGURE 18: TREE #8 CANOPY

Tree #8 is being recommended for removal because it is in the footprint of the proposed building and would not likely survive additional injury due to current lack of vigor. The 42cm (DBH) Siberian Elm has several defects and its overall condition is “Very Poor”.

- Large failures
  - 5-8 limbs, 1-3cm in diameter
- Severe lean to the north
- Cavities containing decay on the main stem
  - 3 significant
  - fruiting bodies present
- Irregular root flare

- Water-sprouting throughout the canopy
- Hanging deadwood
- 2 limbs, 1-3cm in diameter
- Large deadwood
  - 6-8 limbs, (3-5cm)
- 15% of the total canopy is deadwood
- 10% of natural canopy previously failed

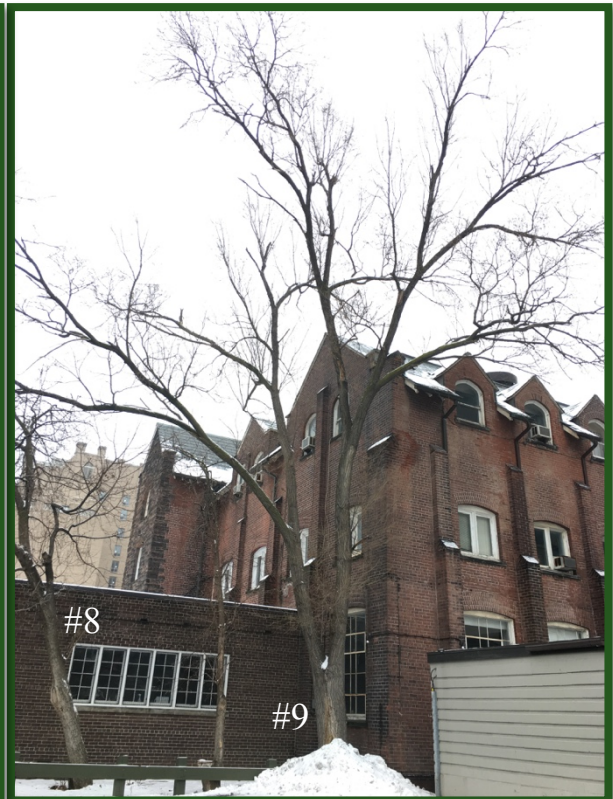
FIGURE 20: TREE #9

Tree #9 is being recommended for removal because it is in the footprint of the proposed building and would not likely survive additional injury due to current lack of vigor. The 67cm (DBH) Siberian Elm has several defects and its overall condition is “Poor”.

- Large failures
  - 10-12 limbs, 3-10cm in diameter
- Included bark and a vertical crack from main union to grade
  - 2.5m in length
- Large wound with decay at base
- Large deadwood
  - 8-10 limb, 3-8cm in diameter
- 15% of the total canopy is deadwood
- 20% of natural canopy previously failed
