## Heritage Impact Assessment

TORONTO ESTONIAN CULTURAL CENTRE

9 and 11 Madison Avenue, Toronto, ON

**DRAFT** - DATE ISSUED: March 12, 2018

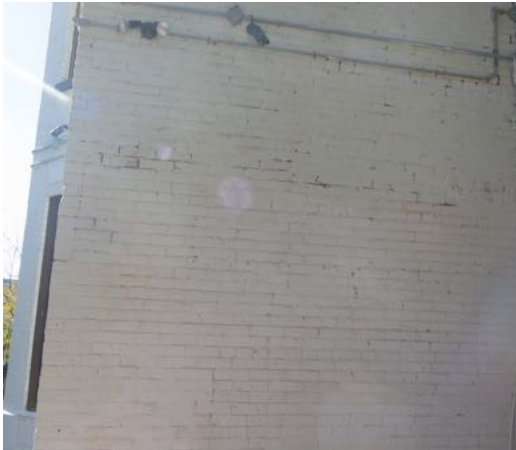
The brick appears to be in fair condition.

The mortar joints condition is hard to determine, without removal of the paint. It is assumed that the masonry joints are in varying degrees of deterioration: open, recessed, cracked or missing. This varying degree of deterioration is commonly found with buildings of this age that have undergone basic maintenance.

Fig. 20, Masonry wall, (East Elevation)

In certain locations on the building, areas of brick appear to be missing their fired face. However, the full extent of the spalling or erosion could not be fully assessed because of the paint coating.

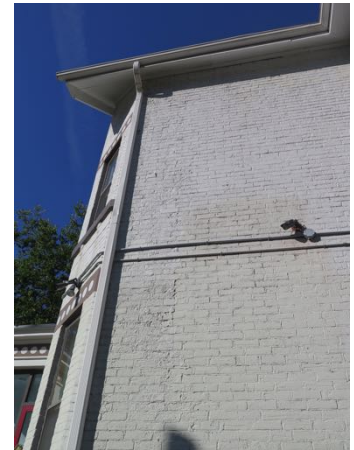
Fig. 21, Masonry wall (South Elevation)

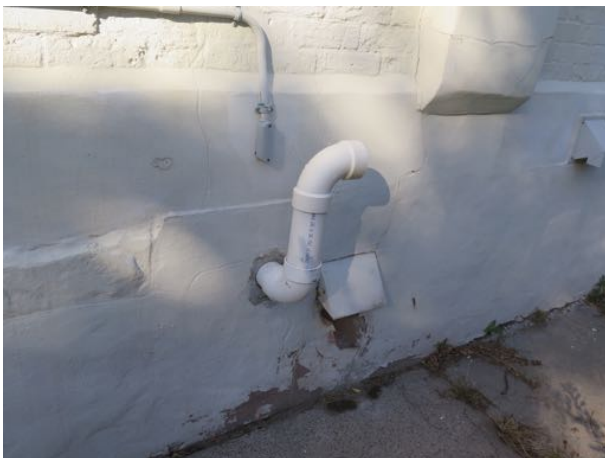
The majority of the stone foundation has been parged. An assumption could be made that the parging was applied to try and stop water infiltration into the building, however, there is no visible evidence in the interior to confirm that assumption. (Basement consists of finished spaces.)

Fig. 22, Above grade foundation wall, parged (South elevation)

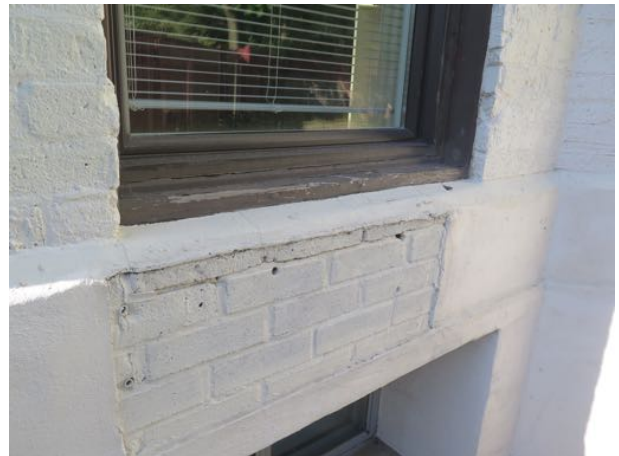
Fig 23, Visible brick at water table line, at modified window (South elevation)

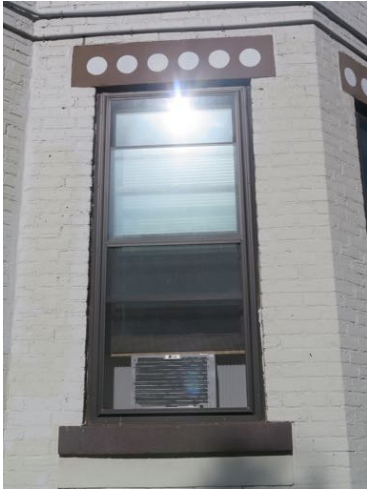
Fig. 24, Exterior of typical window with aluminum storm

There is a mix of replacement and original windows throughout the property. The original painted wood double hung windows are in restorable condition, some are missing the counterweight systems and all are painted shut. A window-by-window assessment was not completed at this time.

The exterior of the windows are protected by aluminum storm windows that are fastened into the face of the wood frames. The storm windows appear to be poor quality and are not in keeping with the heritage character of the building. Based on photographic research the storms were added between 1963 and 1970.

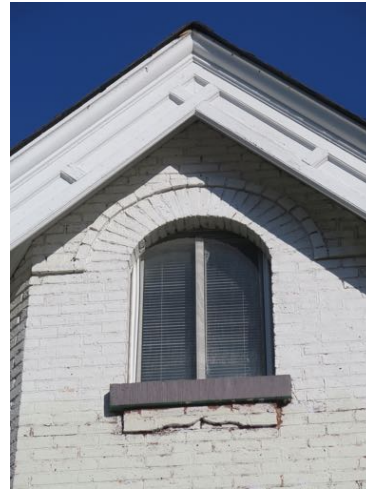
Fig 25, Arched window with brick detailing (replacement window)

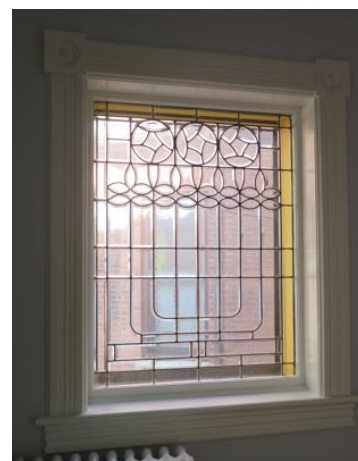
On the north elevation there is a clear leaded glass window. This window may be original. A photo dated 1970, depicts a clear leaded glass window with a different pattern. It appears that the recorded window was located on the north elevation adjacent to the stair between the ground and second floors.

Fig 27, Existing Window (North elevation)

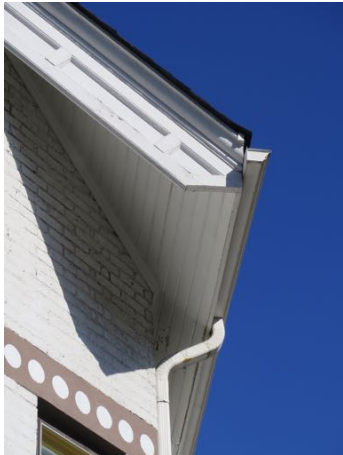
The woodwork of the soffits, and bargeboard appears to be in good condition. Painting is required and likely wood replacement will be required, where the wood has been exposed or joints have opened up. To fully understand the extent of the restoration a close up inspection is required. The wood would be reviewed for exposure, rot, cracking and brittleness.

*Fig 28, West elevation bargeboard and soffit*

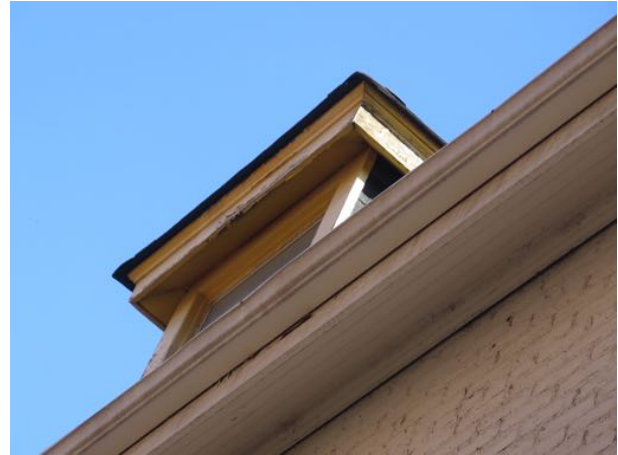
*Fig 29, North elevation wood dormer and soffits*

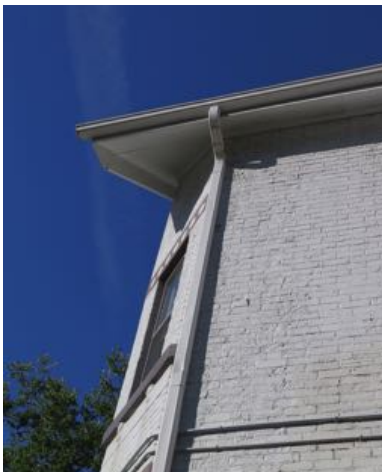
The k-style eaves troughs and square rainwater leaders are standard residential pre-finished aluminum. They are likely reaching the end of their life span and should be replaced. The joints are beginning to rust and some rainwater leaders are dented.

*Fig 30, Rainwater leader and eaves trough on southwest corner*
