## TREE PRESERVATION PLAN AND ARBORIST REPORT

Prepared for North Design Office Inc.  
9 Madison Avenue Toronto

FEBRUARY 6, 2018

ADDRESS: 9 MADISON AVENUE. TORONTO. M5R 2S2

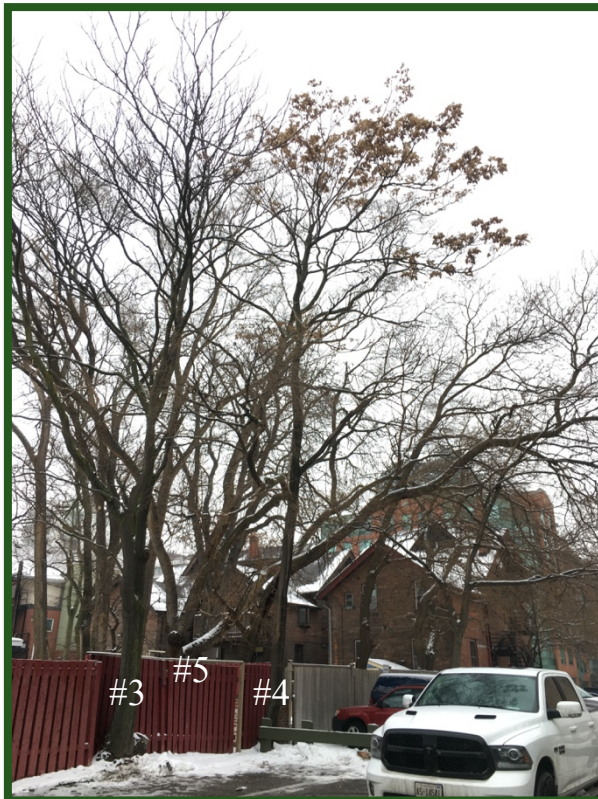
FIGURE 7: TREE #3-5

| Tree # | Species | Common Name | DBH (cm) | Category | Condition | Comments on Condition | TPZ (m) | Recommendation | Rationale | Injury Mitigation |
|---|---|---|---|---|---|---|---|---|---|---|
| 3 | <i>Ailanthus altissima</i> | Tree of Heaven | 44 | 1 | Poor | damage at the base, lg failures, failed co-dominant stem (20cm), cavity formation throughout, limited softscape, 20% total deadwood, 10% of natural canopy failed | 3 | Removal | Poor condition, in footprint of the proposed structure | N/A |
| 4 | <i>Ailanthus altissima</i> | Tree of Heaven | 32 | 1 | Poor | damage at the base, lg failures, lg deadwood (3-5cm), cavity formation throughout, limited softscape, vertical crack on the main stem (2m), 15% total deadwood, 30% of natural canopy failed | 2.4 | Removal | Poor condition, in footprint of the proposed structure | N/A |

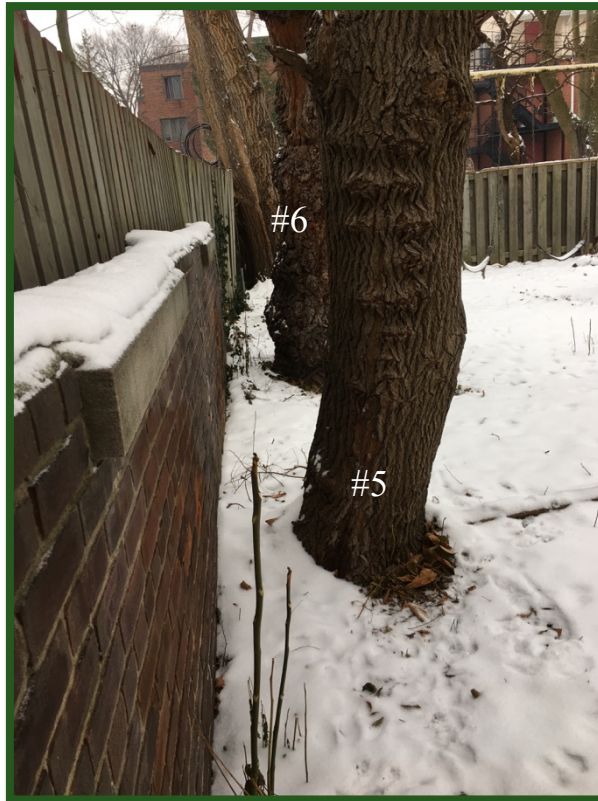
FIGURE 13: TREE #5-6 MAIN STEMS

| Tree # | Species | Common Name | DBH (cm) | Category | Condition | Comments on Condition | TPZ (m) | Recommendation | Rationale | Injury Mitigation |
|---|---|---|---|---|---|---|---|---|---|---|
| 5 | <i>Ulmus pumila</i> | Siberian Elm | 38 | 2 | Poor | lean to the south-west, lg failures, lg deadwood (3-5cm), bacteria wetwood, 20% total deadwood, 10% of natural canopy failed | 2.4 | Protect | Poor condition, in footprint of the proposed structure | |
| 6 | <i>Ulmus pumila</i> | Siberian Elm | 63 | 2 | Fair | lg failures, lg deadwood (5-15cm), 20% total deadwood, 15% of natural canopy failed | 4.8 | Injury | >6m from construction, limb will interfere with proposed structure | Limb pruning the provide adequate clearance from construction, 1 limb 20cm in diameter mostly deadwood (figure __) |

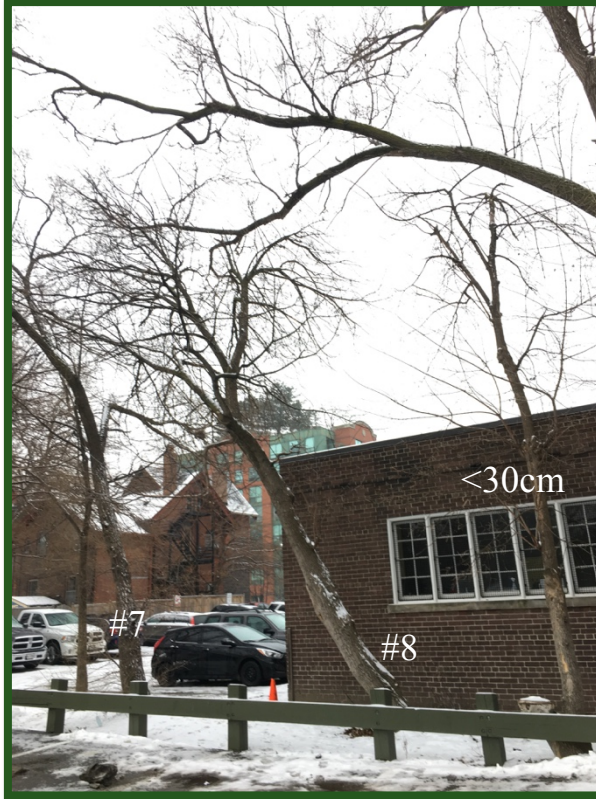
FIGURE 17: TREE #7-8

| Tree # | Species | Common Name | DBH (cm) | Category | Condition | Comments on Condition | TPZ (m) | Recommendation | Rationale | Injury Mitigation |
|---|---|---|---|---|---|---|---|---|---|---|
| 7 | <i>Ulmus pumila</i> | Siberian Elm | 37 | 1 | Poor | lg failures, lg deadwood (3-8cm), severe lean, irregular root flare, hanging deadwood, water-sprouting at the base, 30% total deadwood, 10% of natural canopy failed | 2.4 | Removal | Poor condition, in footprint of the proposed structure | N/A |
| 8 | <i>Ulmus pumila</i> | Siberian Elm | 42 | 1 | Very Poor | lean to the north, cavities with decay on the main stem, fruiting bodies on the main stem, lg failures, lg deadwood (3-5cm), hanging deadwood (1-3cm), 15% total deadwood, 10% of natural canopy failed | 3 | Removal | Poor condition, in footprint of the proposed structure | N/A |
