## Heritage Impact Assessment

TORONTO ESTONIAN CULTURAL CENTRE

9 and 11 Madison Avenue, Toronto, ON

**DRAFT** - DATE ISSUED: March 12, 2018

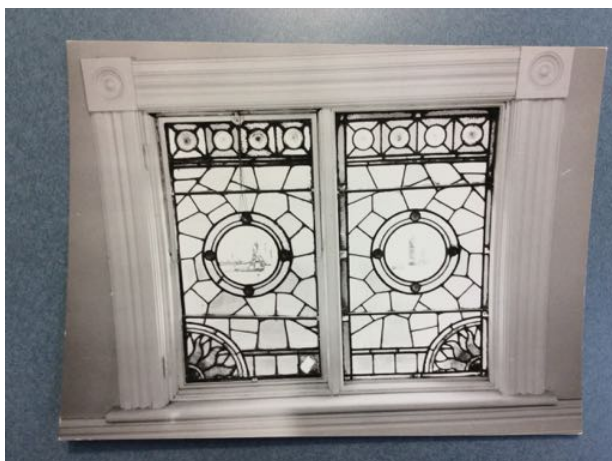
Fig 26, 1970s photograph of window (North elevation)

On the north elevation there is a clear leaded glass window. This window may be original. A photo dated 1970, depicts a clear leaded glass window with a different pattern. It appears that the recorded window was located on the north elevation adjacent to the stair between the ground and second floors.

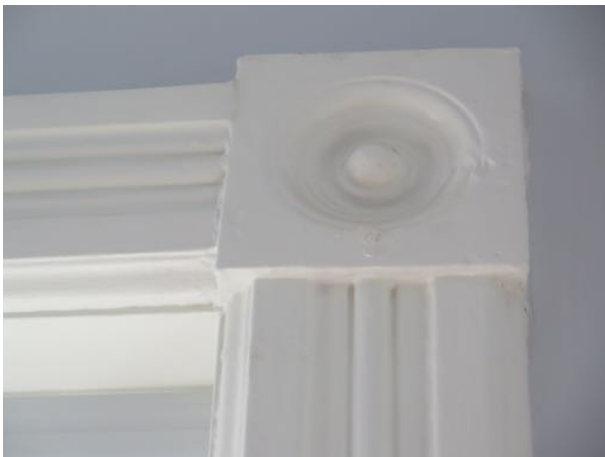
The interior finishing details include tall baseboards in limited locations, 6" window and door casings with rosettes, a partial wood handrail, and decorative radiators.

*Fig 31, Original rosette at window casings*

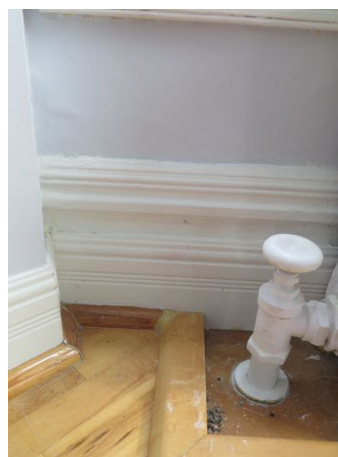
*Fig 32, Original baseboard*

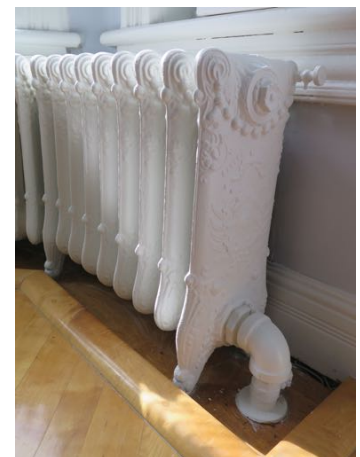
*Fig. 33, Decorative radiator*
